# Honda Accord LX Broadside Collision With a Narrow Fixed-Object: FOIL Test Number 97S006

PUBLICATION NO. FHWA-RD-98-011

JANUARY 1998

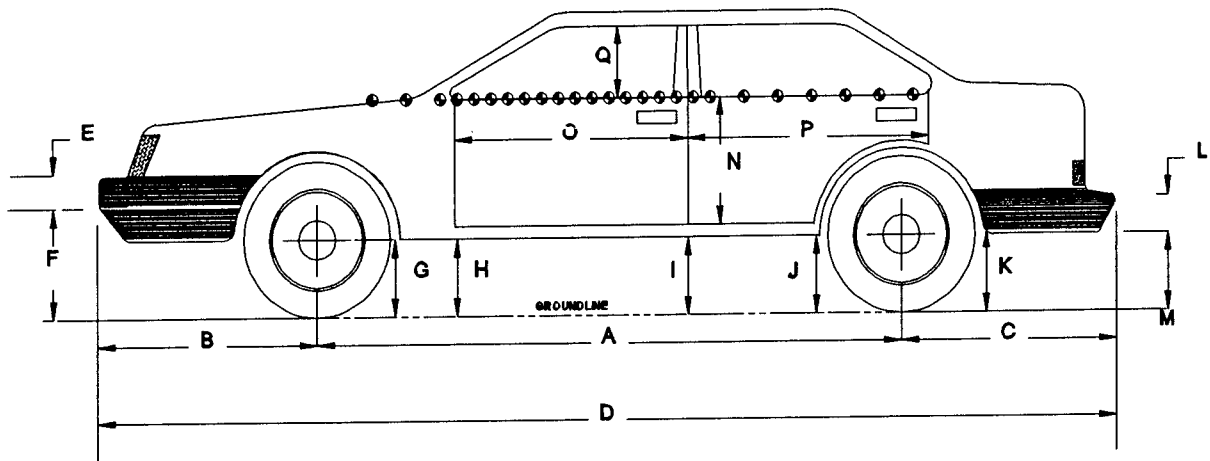
PRE-TEST	POST-TEST	ΔCHANGE
A	2,718	2,508	-210
B	889	889	0
C	965	1,016	51
D	4,572	4,413	-159
E	114	114	0
F*	429 / 416	286	-130
G*	286 / 260	276	16
H*	286 / 260	270	10
I*	292 / 260	298	38
J1*	295 / 264	324	60
J2*	197 / 192	206	14
K*	356 / 325	362	37
L	216	216	0
M*	394 / 375	381	6
N	679	673	-6
O	826	756	-70
P	1,241	1,092	-149
Q	457	425	-32

\* These measurements were taken in the "as delivered" and in the "as tested" configuration, respectively.

Figure 1. Vehicle physical parameters in millimeters.

A list and sketches of the vehicle's physical parameters are shown in table 2 and figure 1, respectively. Figure 1 includes post-test damage measurements.

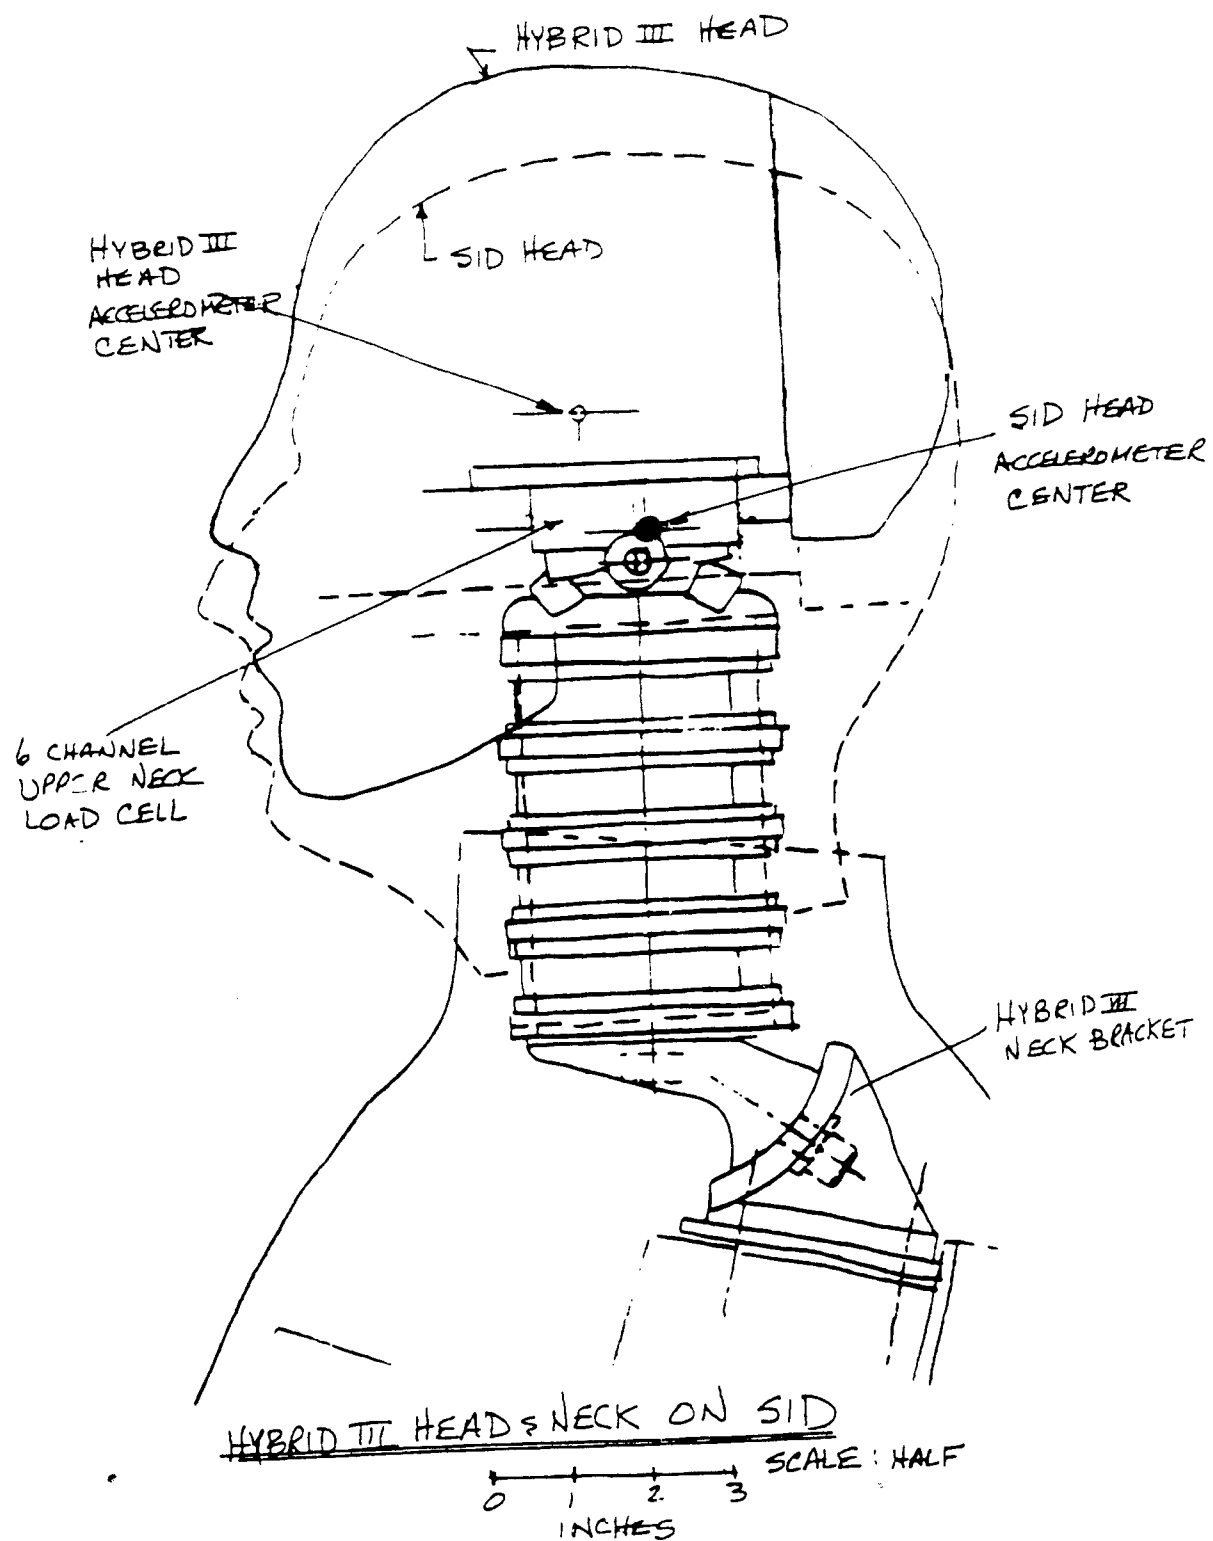
Figure 2. HYBRID III neck and head assembly on SIDH3 #26.

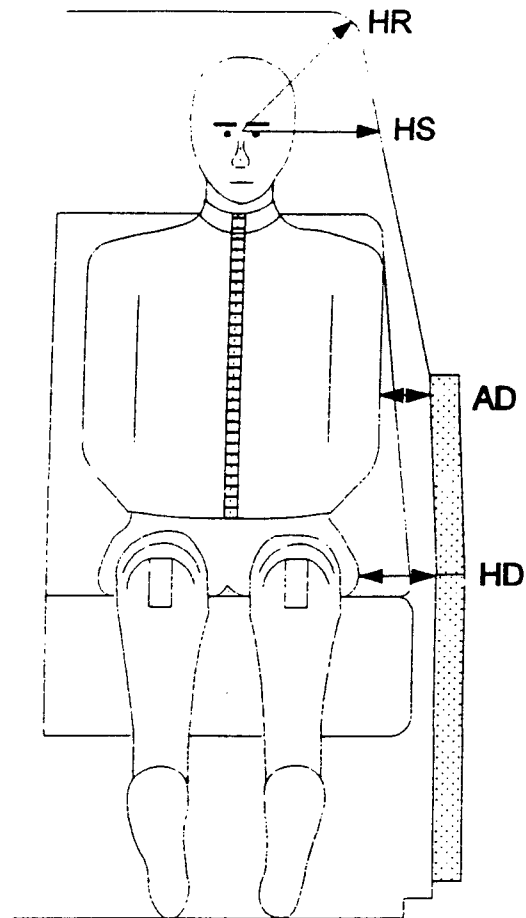
MEASUREMENT (mm)	DRIVER SIDH3 ID# 26
HR	220
HS	320
AD	106
HD	142

Figure 4. SIDH3 lateral clearance and position measurements.

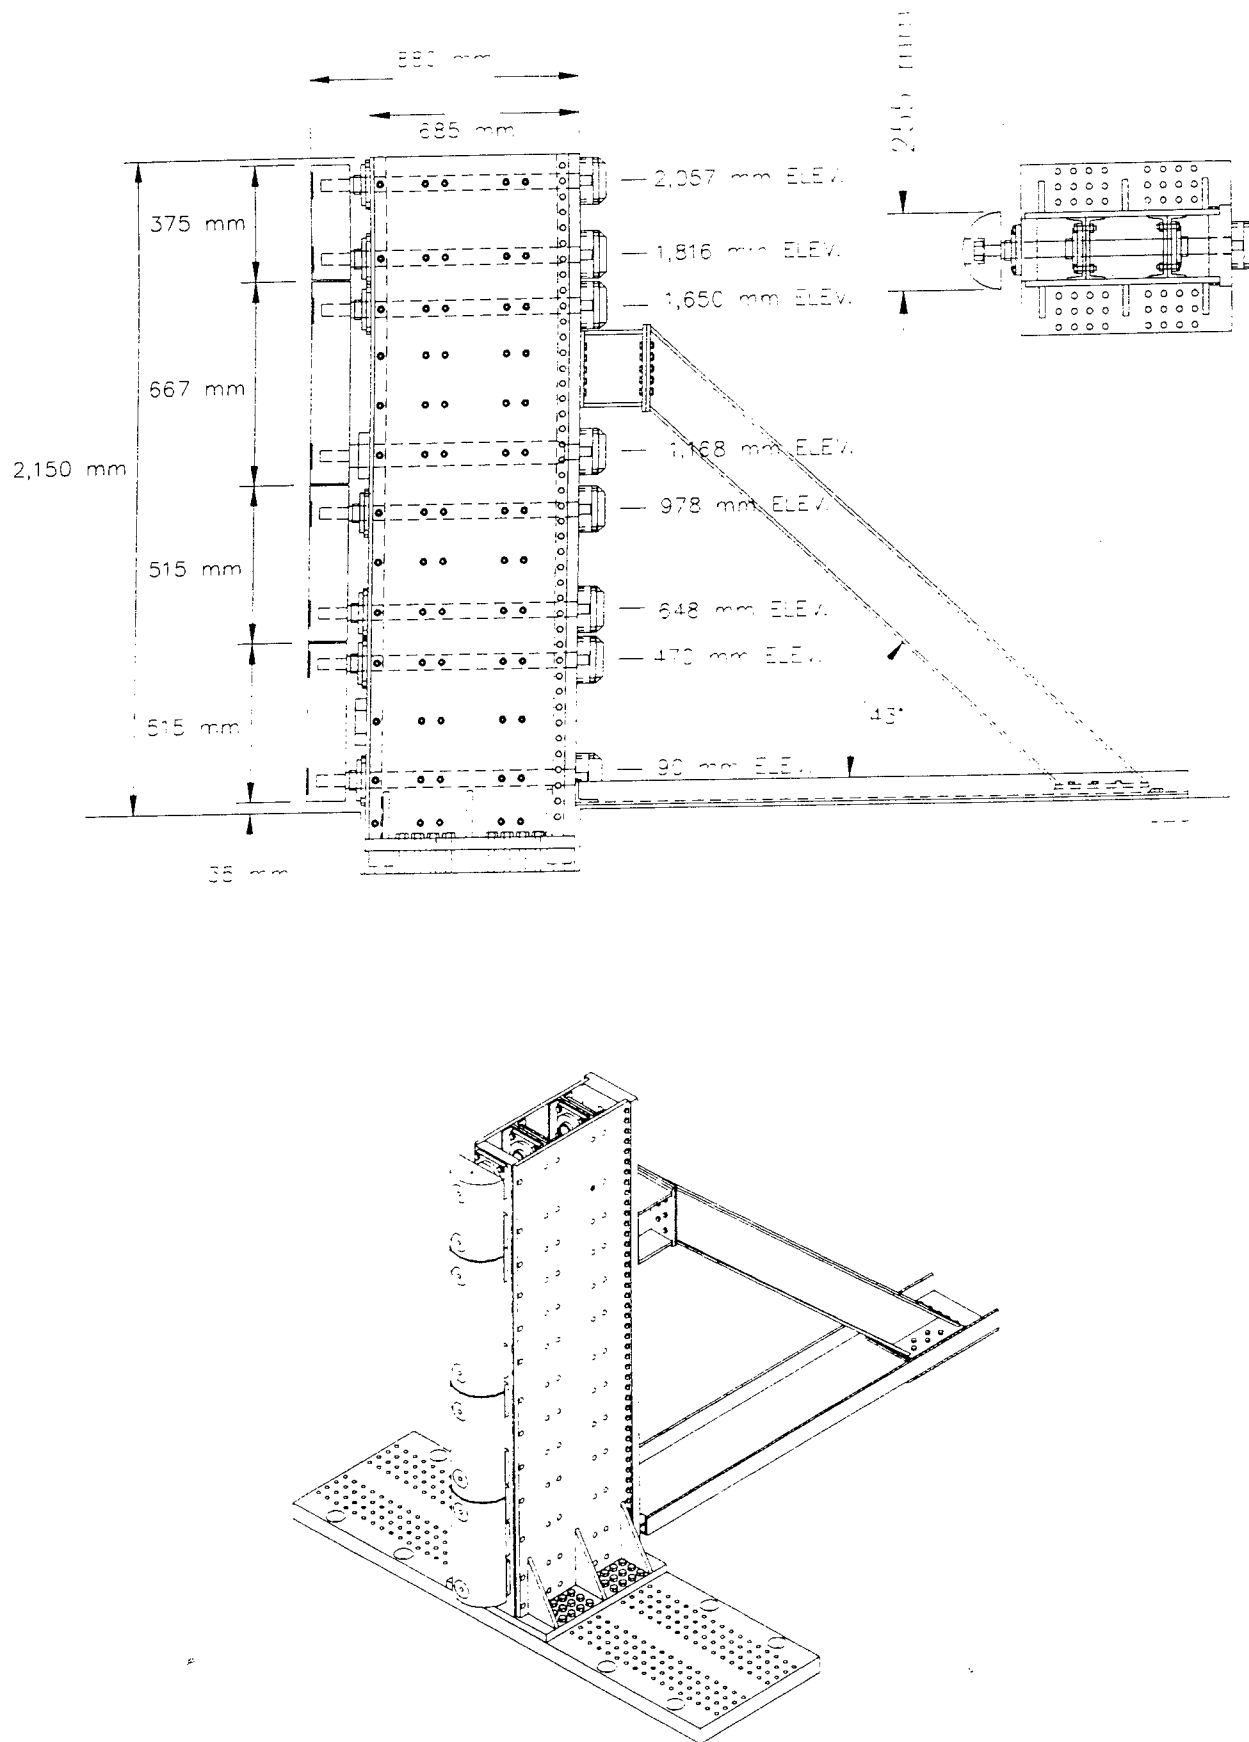
Figure 5. FOIL 300K instrumented rigid pole.

Rigid pole. The load cells measured eight separate forces on the rigid pole. The total load from summing the eight load cells was 104,600 N. The significant loads were contributed by the roof-rail, floor-sill, and middle-point of the driver door. Table 9 summarizes the load cell data. The high-speed film revealed that the roof sill did not contact the top impact face of the rigid pole. The signals from the top two load cells may not be reliable. It was not clear what phenomena caused the signals, which are presented in this report. Exclusion of the data from the top two load cells yields a peak rigid pole force of 104,450 N at 0.0548 s. The signals from the top two load cells did not affect the overall force-time history during the main collision event. The peaks recorded from the top two load cells occur later (0.300 s) relative to peaks recorded from other

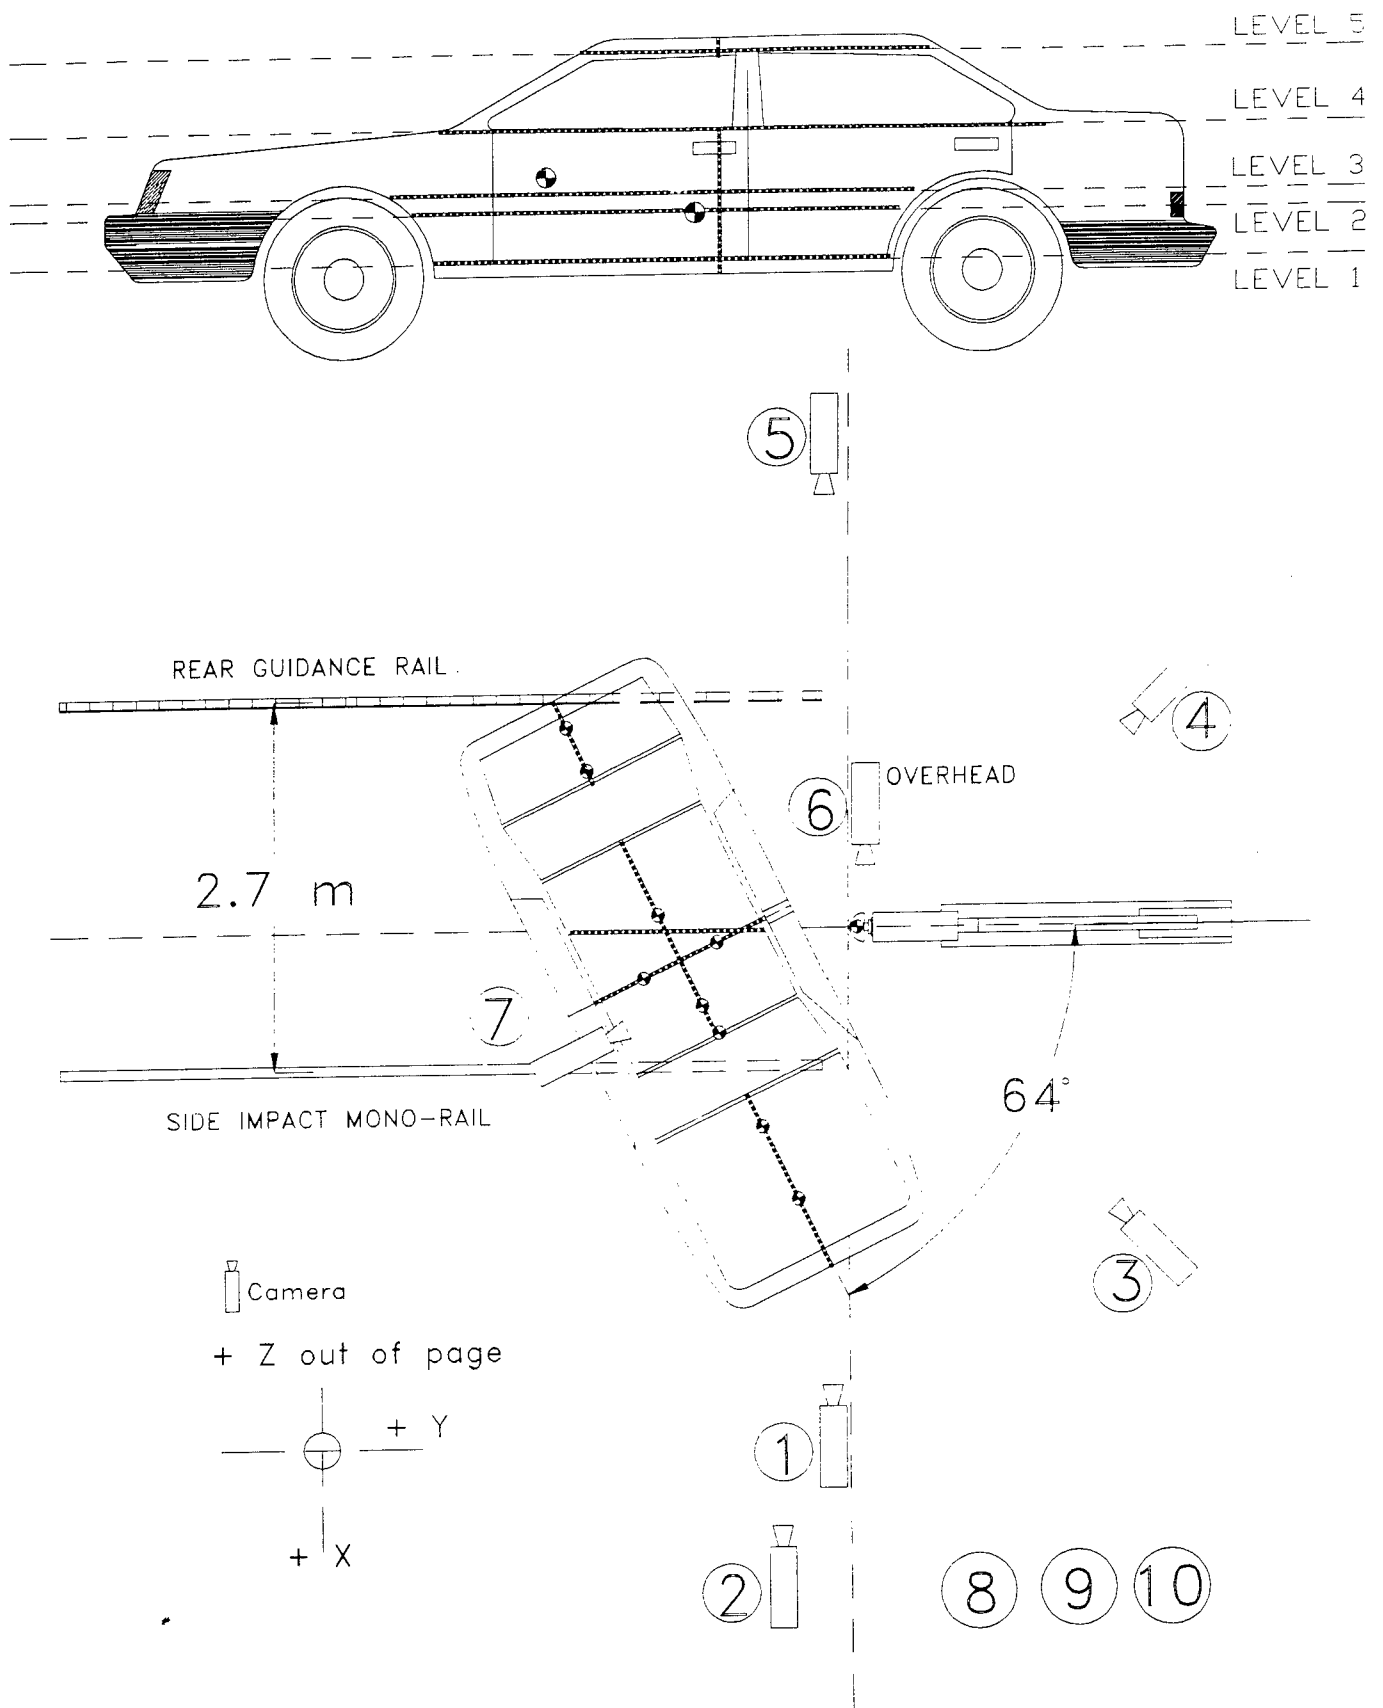
Figure 6 presents a side view of the test vehicle, showing the target tape locations. Figure 6 also contains an overhead sketch of the facility depicting the setup of the vehicle, rigid pole, test track, and the location of each high-speed camera. Positioned in each camera's view was at least one strobe light. The lights flashed when the vehicle struck the pole. This synchronized the film with the electronic data.

Figure 6. Camera locations and test setup.

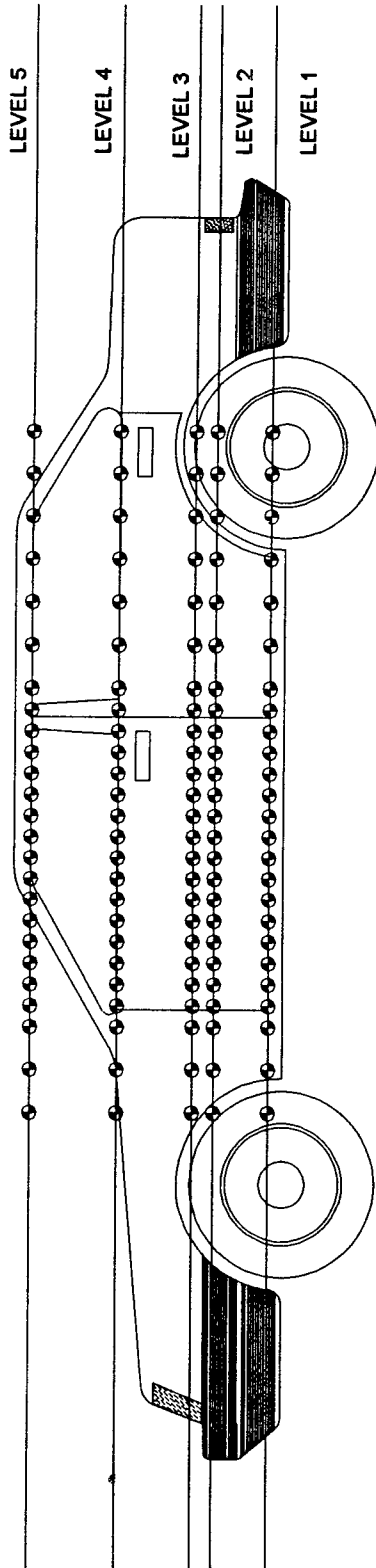
Level 1 - Sill height Level 2 - Occupant H-point Level 3 - Mid-door Level 4 - Window sill Level 5 - Window top

Distance from impact point (mm).													
LEVEL	HEIGHT	-1219	-1067	-914	-762	-610	-533	-457	-381	-305	-229	-152	-76	0	
1	279	PRE	629	622	622	616	616	613	610	603	603	597	597	597	
	298	POST	530	581	645	714	784	819	860	918	968	994	984	940	
		CRUSH	-99	-41	23	92	168	203	247	308	365	391	387	343	
2	422	PRE	584	578	578	578	578	575	575	572	572	568	565	562	
	457	POST	489	556	638	718	806	848	886	937	978	1010	994	946	
		CRUSH	-95	-22	60	140	228	270	311	362	406	438	426	381	
3	575	PRE	584	578	578	578	578	575	575	572	572	568	565	562	
	603	POST	470	559	648	711	743	873	914	959	1000	1019	1016	965	
		CRUSH	-114	-19	70	133	165	295	339	384	428	447	448	400	
4	867	PRE	641	641	641	635	635	635	635	637	637	641	641	641	
	927	POST	524	559	629	721	813	864	911	959	997	1026	1035	1054	
		CRUSH	-117	-82	-12	86	178	229	276	324	360	389	394	413	
5	1372	PRE						908	902	899	895	895	895	895	
	1403	POST						927	953	987	1019	1054	1081	1086

Target tape and circular targets were placed on the test vehicle in accordance with FMVSS 214. The 25-mm yellow and black target tape was placed along the struck side of the vehicle at five elevations. The elevations included the lower door sill, the mid-door height, occupant H-point height, top-door sill, and roof sill. The target tape was used to measure pre- and post-test side profile measurements to determine vehicle damage or crush. The FOIL used a 2.5 m long by 1.4 m high peg board placed along the driver (left) side of the vehicle to measure the vehicle profile. The board's position was referenced from two points directly across from the impact location on the right side of the vehicle. This was done to ensure that the reference location would not be severely damaged. The two points were chosen directly across from impact because the least amount of bowing occurs directly across from impact. It was necessary to position the board in the same position relative to the vehicle after the crash test to obtain accurate crush measurements. The pre- and post-test profile measurements are shown in figure 7 later in this report.

After the test a damage profile of the vehicle was produced. Figure 7 depicts the driver-side profile measurements before and after the test. The measurements were made using a reference line parallel to the driver side of the vehicle. The parallel line was drawn a certain distance from and perpendicular to a line formed by the passenger side sill across from the impact location. This allowed the same reference line to be drawn after the test to measure the post-test measurements. The measurements were made in 75-mm and 150-mm increments forward and aft of the impact point. After the test, measurements were taken at the same points forward and aft rather than measuring at the same increments. From the figure, the maximum static deflection recorded was 450 mm at the mid-door height, 125 mm rearward from the vertical impact target tape.

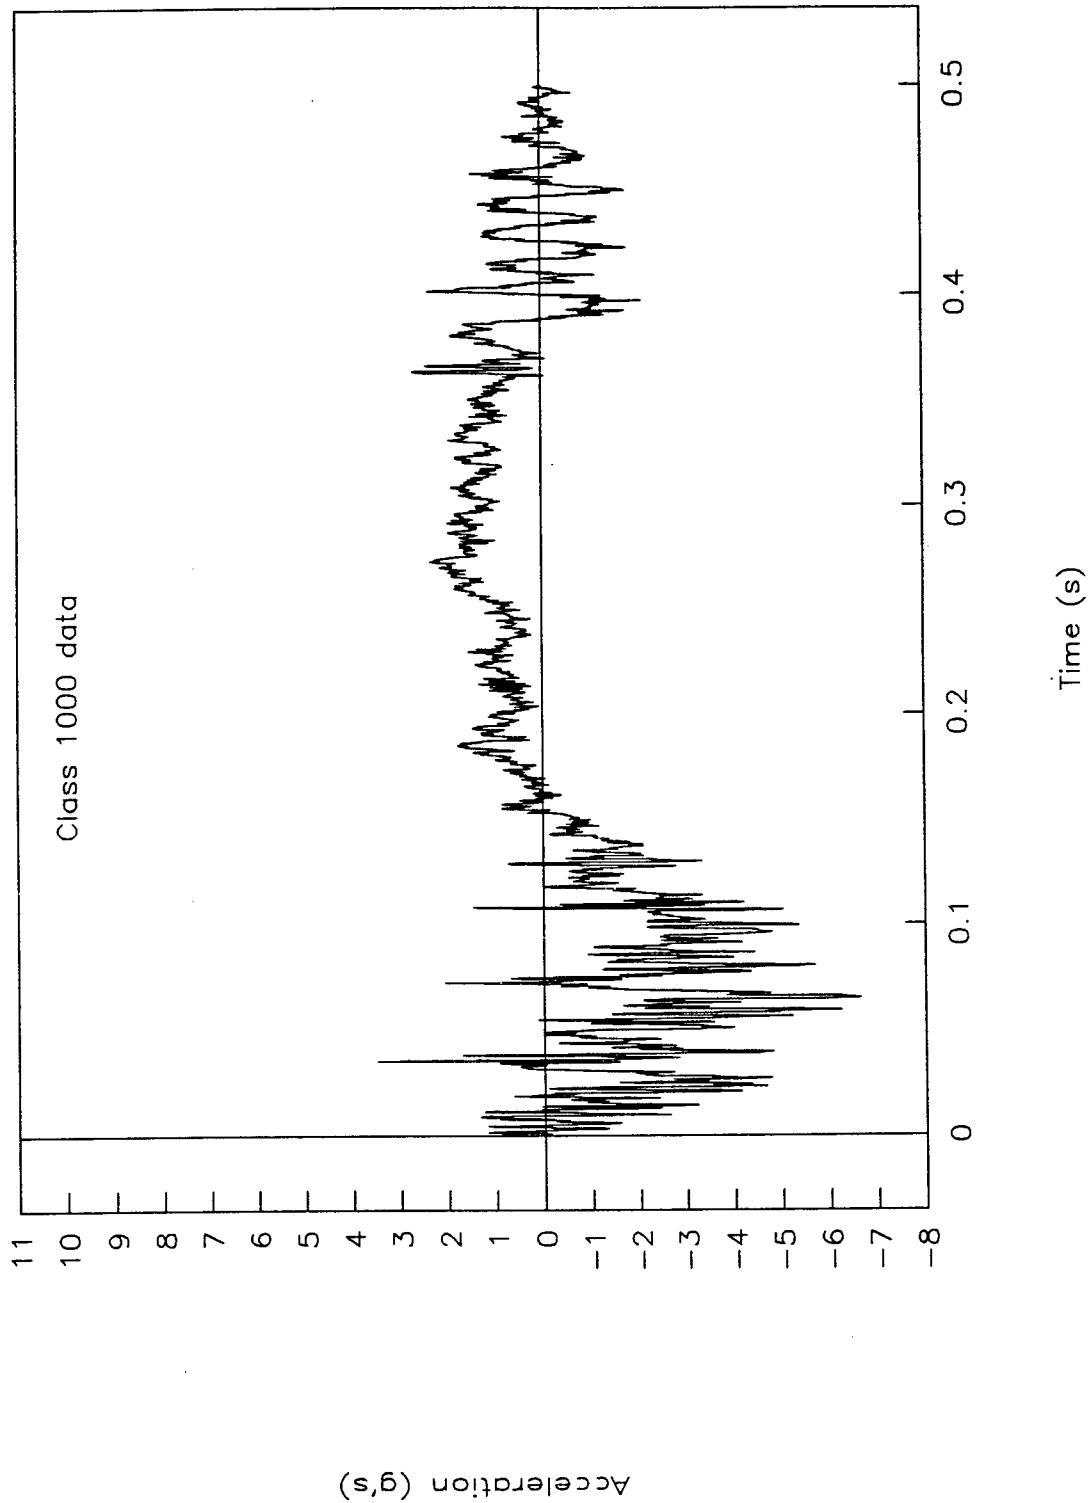
X-axis, acceleration vs. time cg data

Figure 8. Acceleration vs. time, cg X-axis, test 97S006.

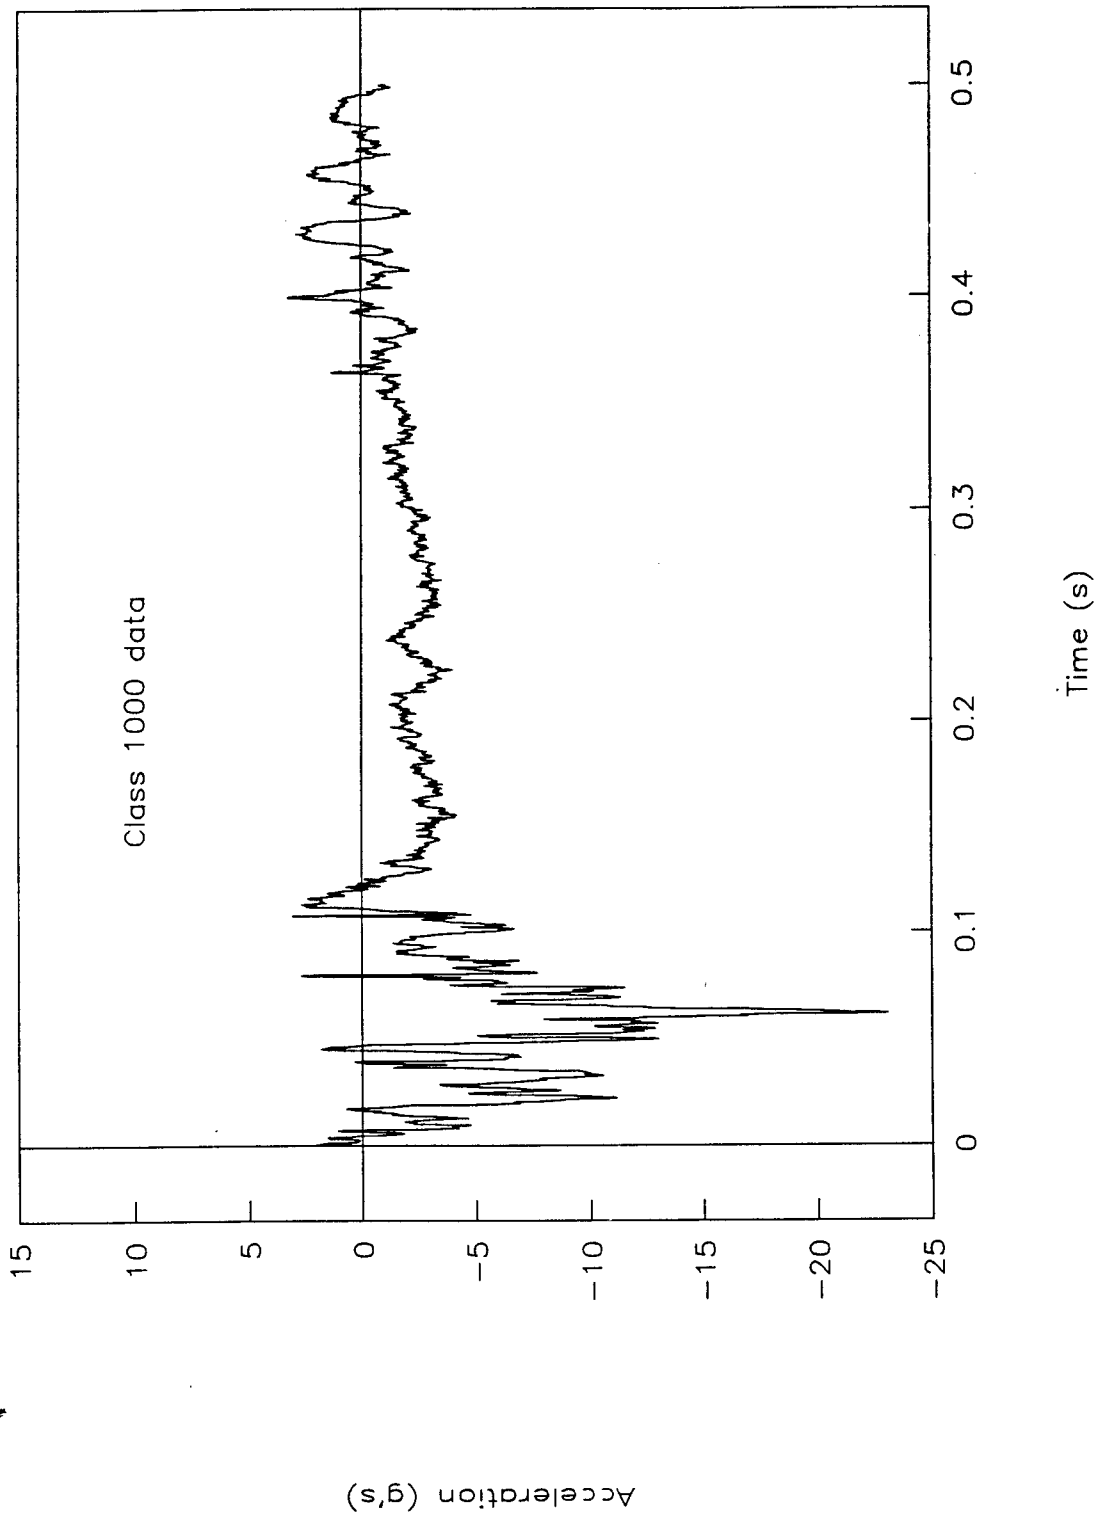
Figure 9. Acceleration vs. time, cg Y-axis, test 97S006.

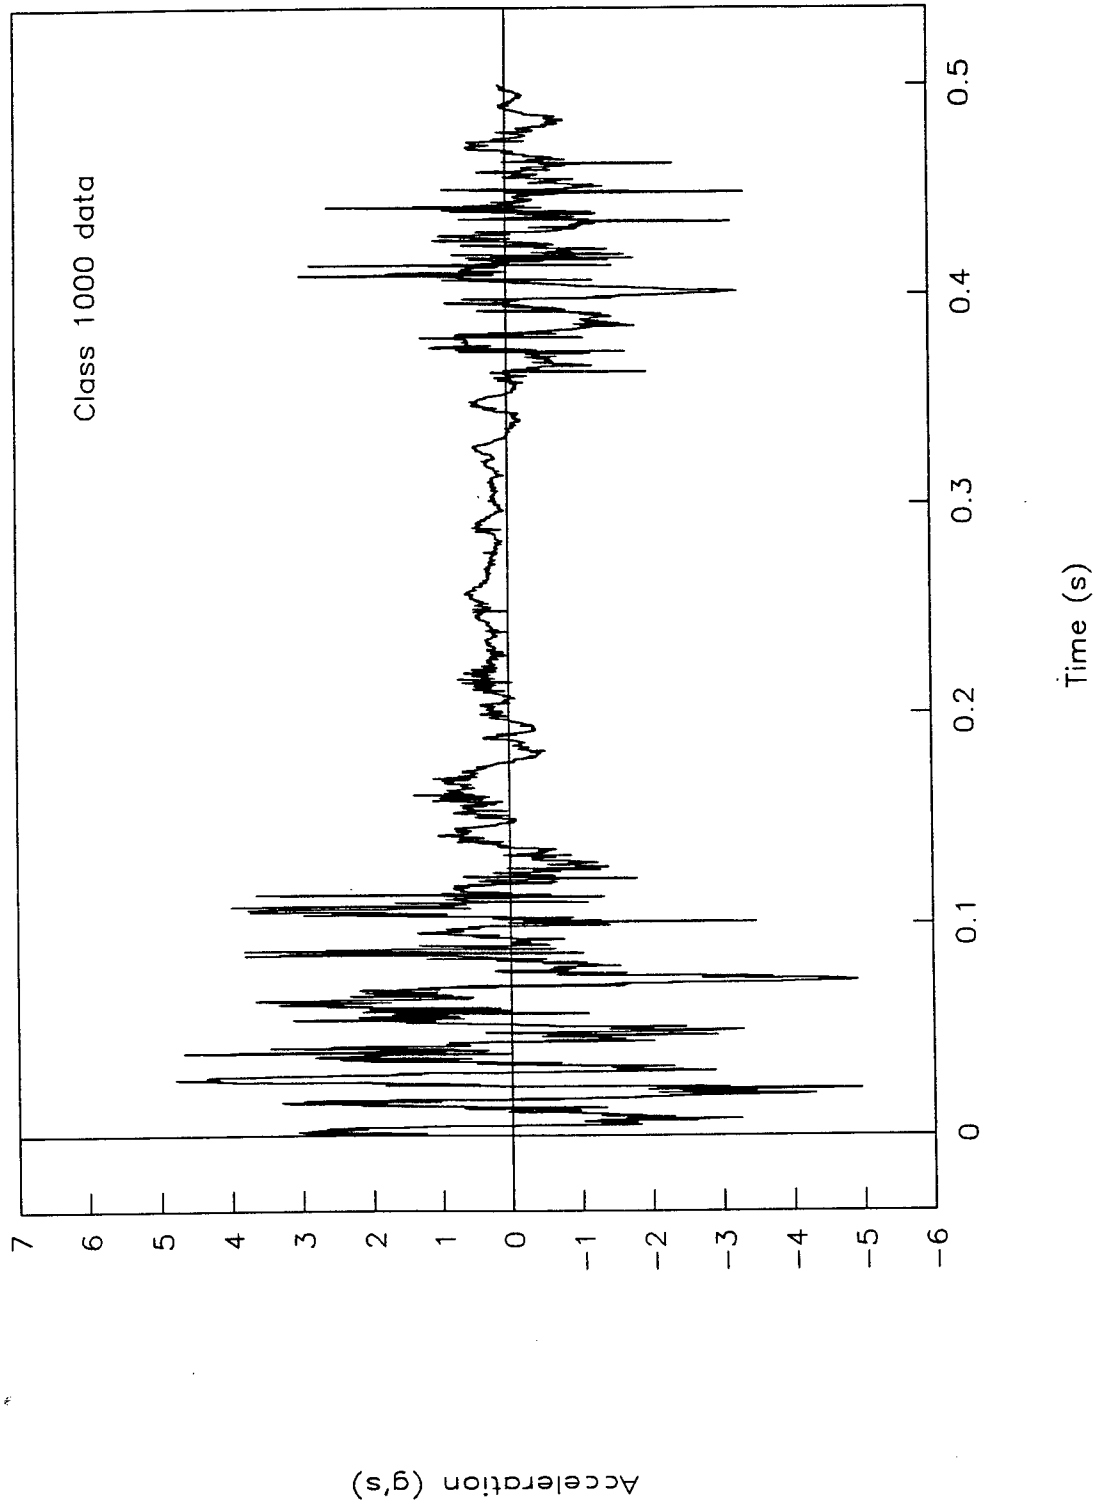
Figure 10. Acceleration vs. time, cg Z-axis, test 97S006.

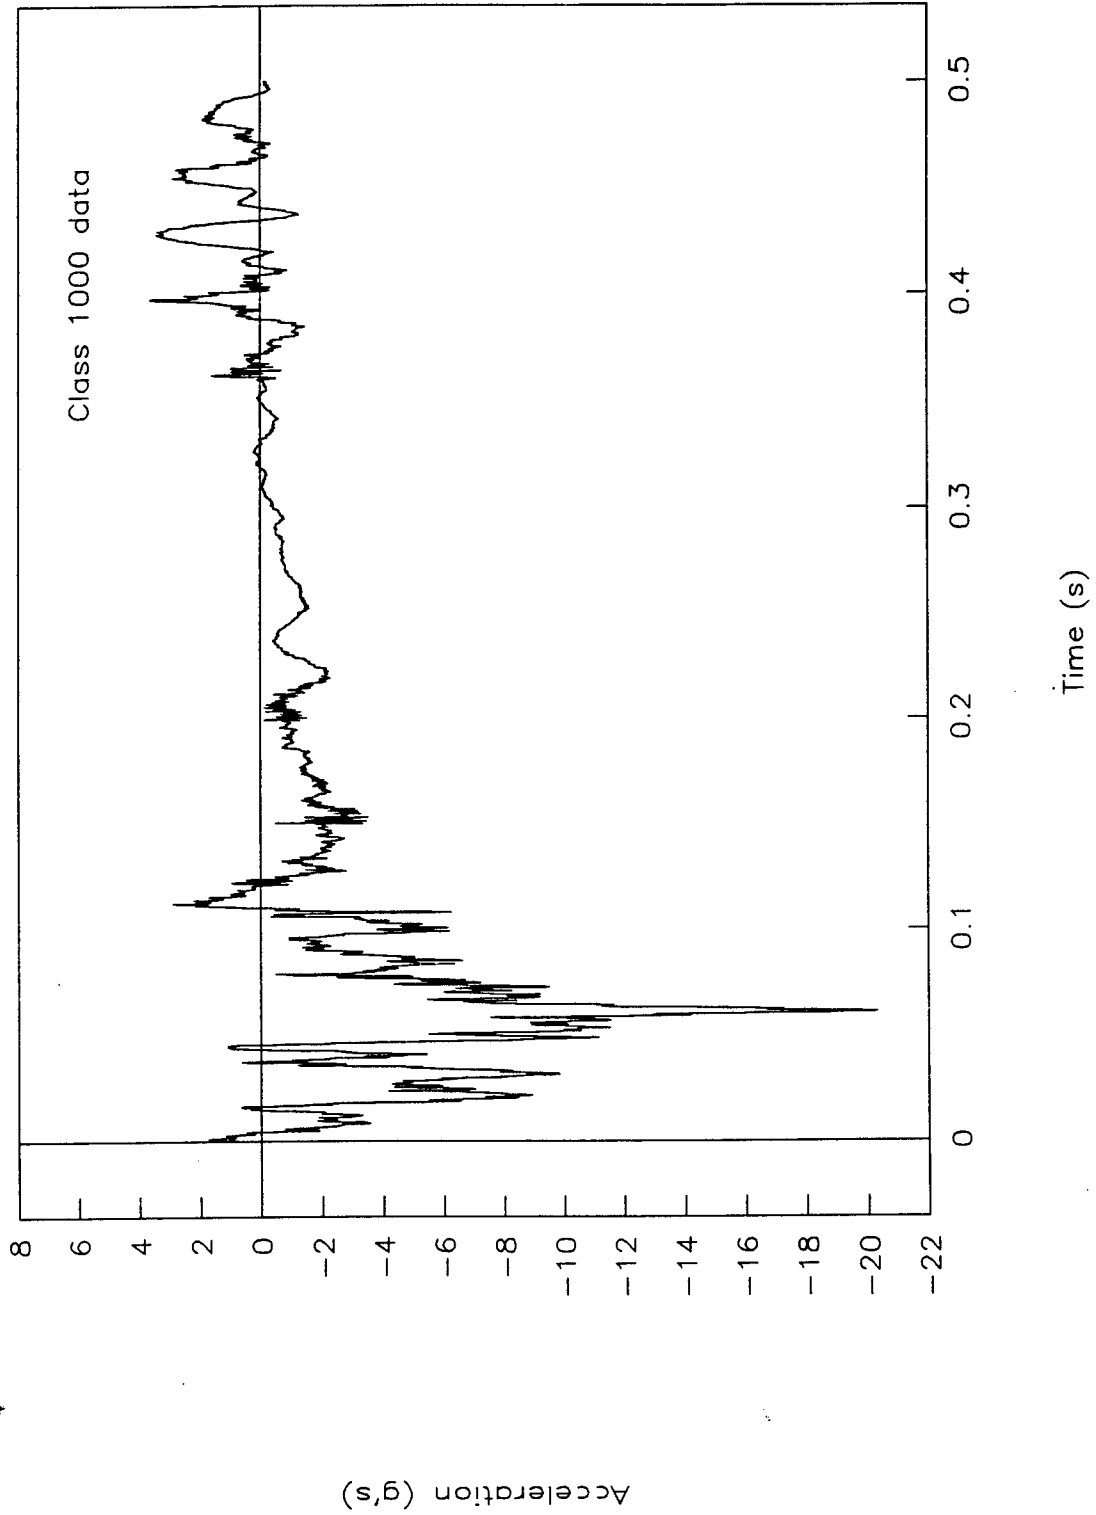
Figure 11. Acceleration vs. time, redundant Y-axis cg, test 97S0006.

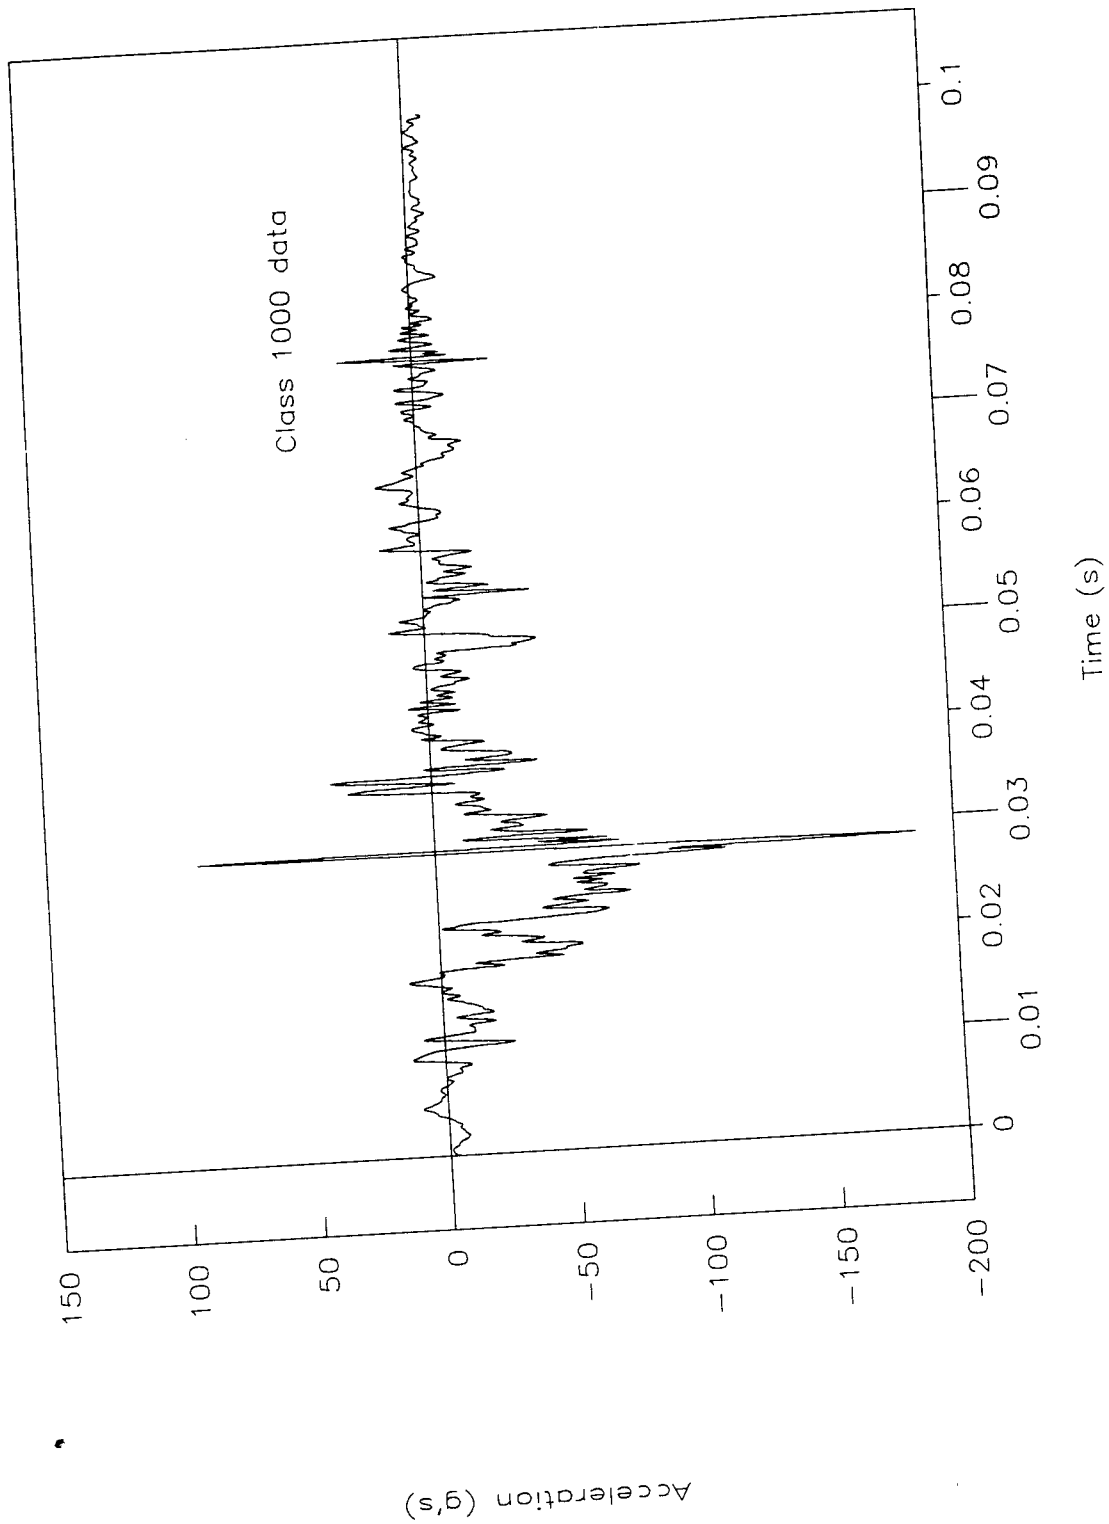
Figure 12. Acceleration vs. time, Y-axis driver seat track, test 97S006.

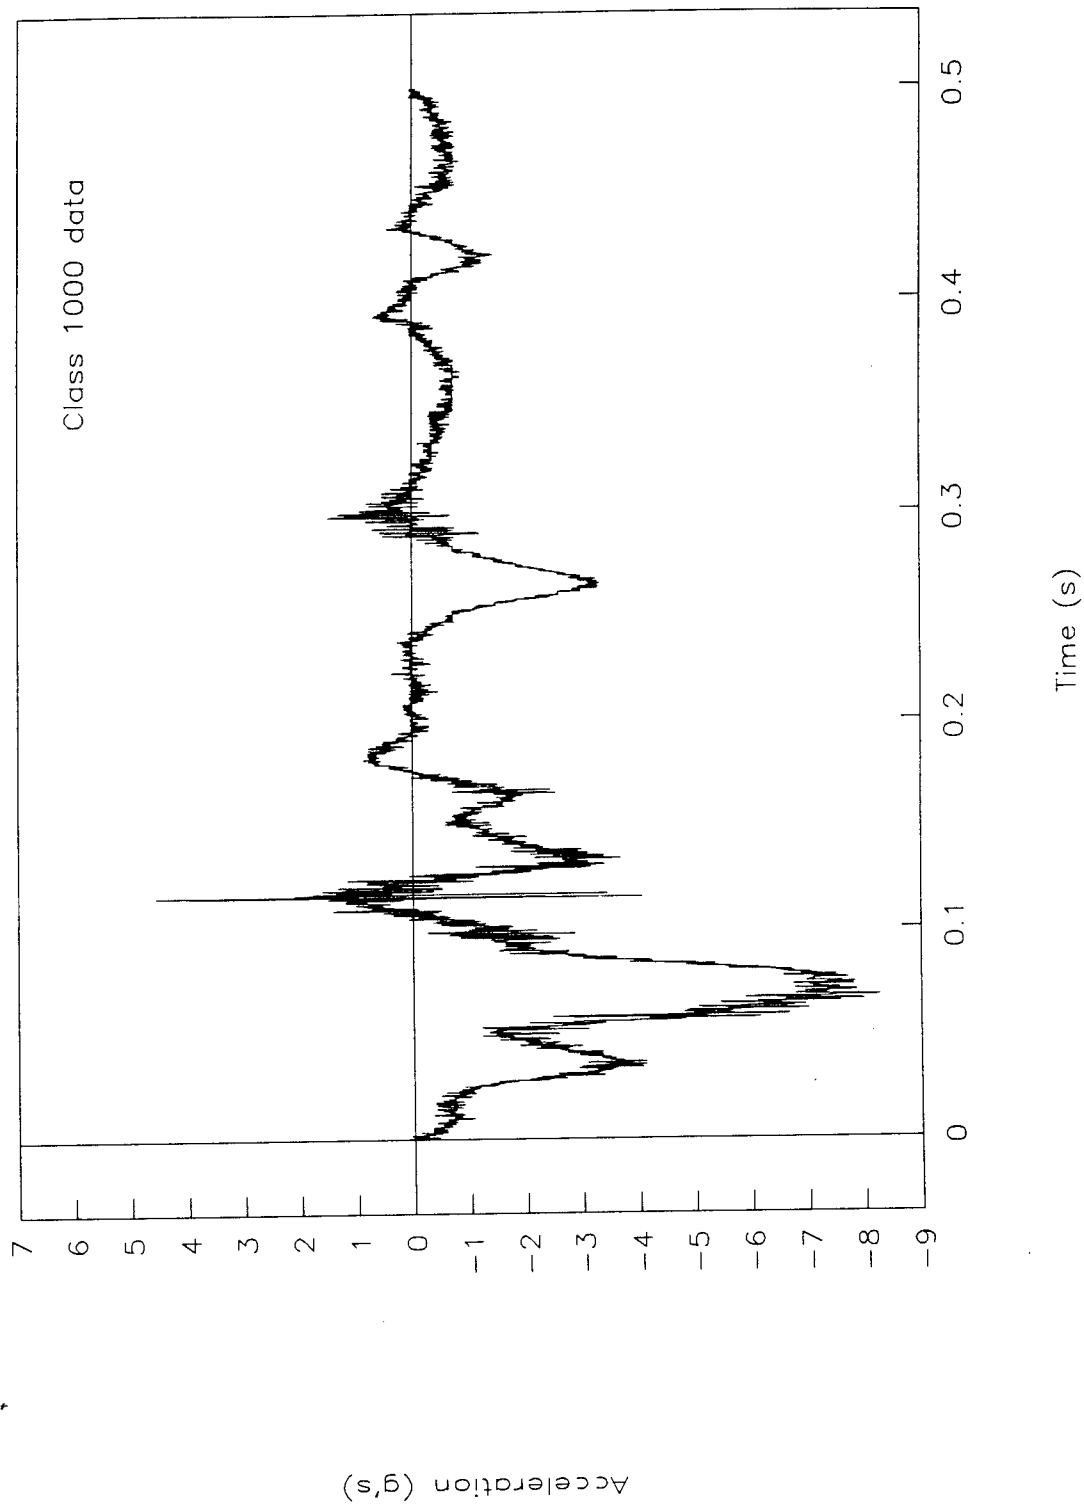
Figure 13. Acceleration vs. time, X-axis engine block, test 97S006.

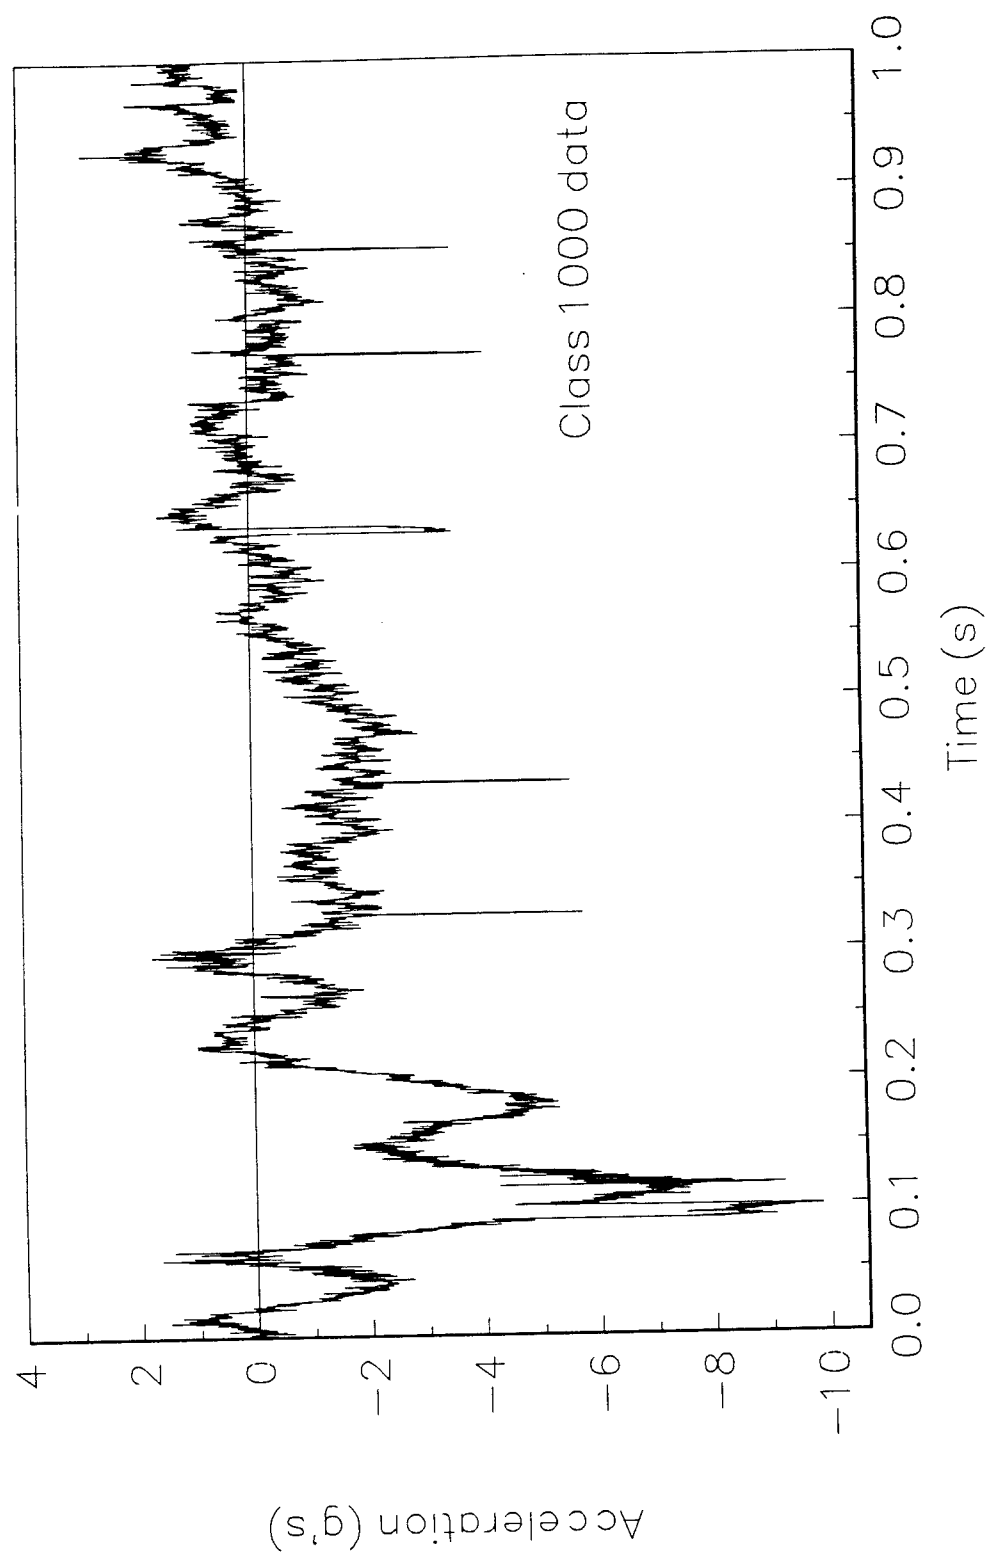
Figure 14. Acceleration vs. time, Y-axis engine block, test 97S006.

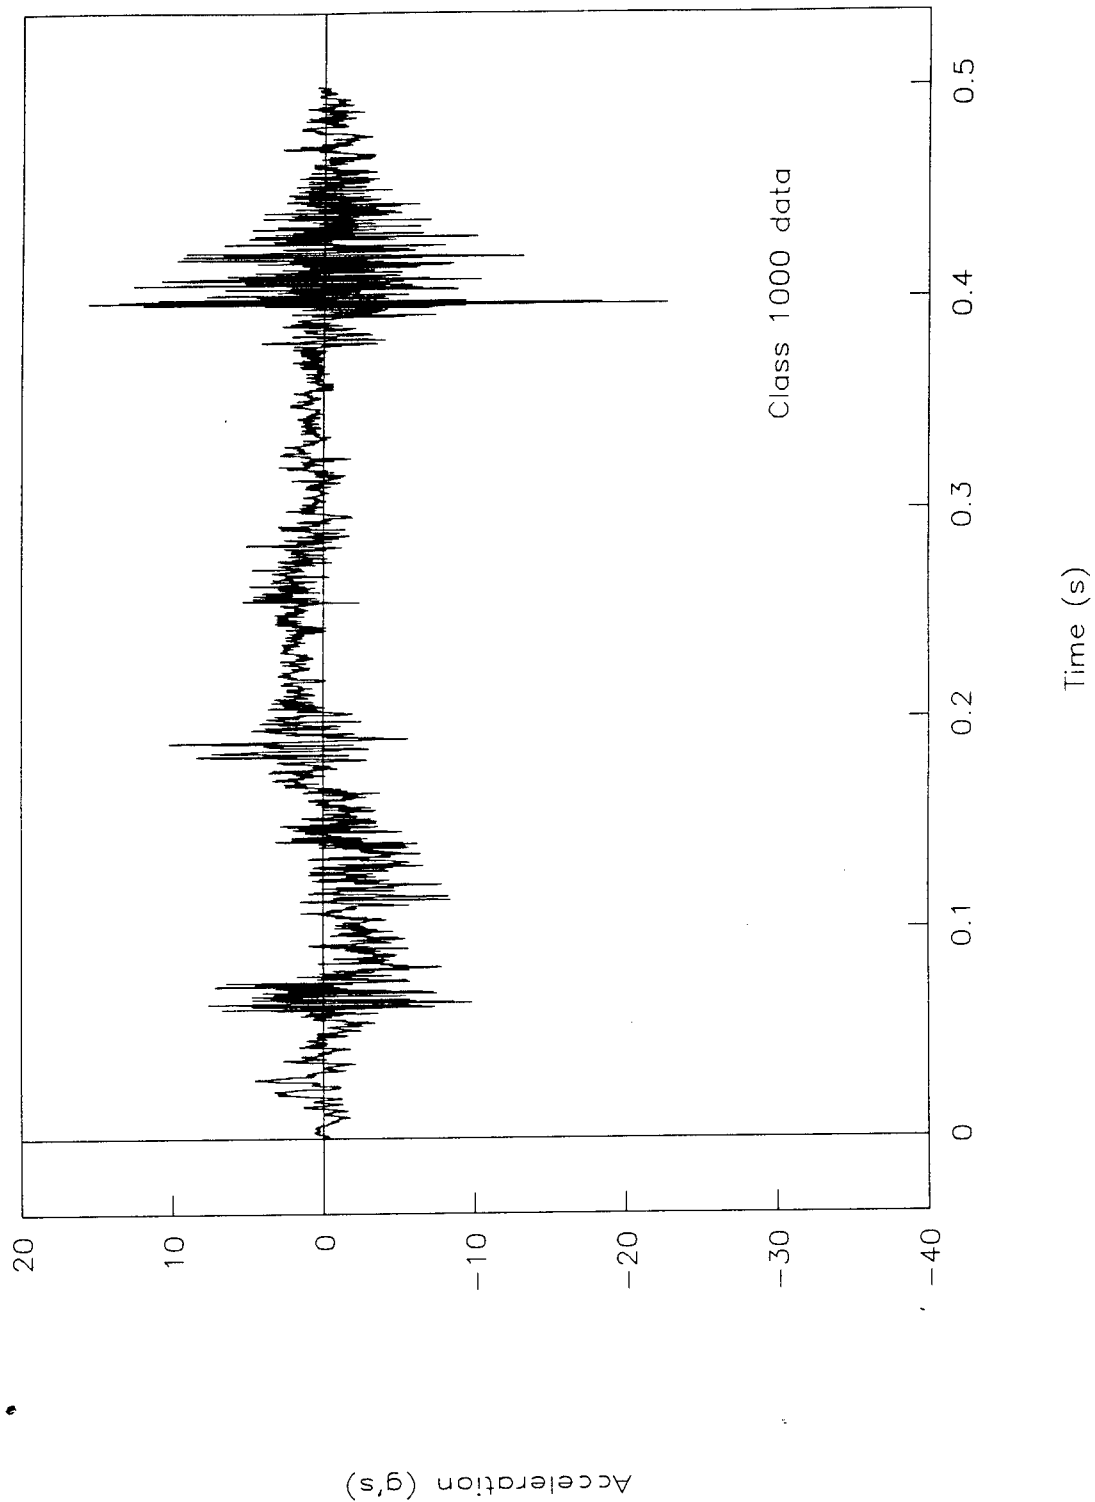
Figure 15. Acceleration vs. time, X-axis trunk, test 97S006.
